Field demonstration of large scale stationary power and CHP fuel cell system

Demonstration of a combined heat and power 2MWe PEM fuel cell generator and integration into an existing chlorine production plant

Deliverable No.	D6.8	
Deliverable Title	Report on stack failure causes	
Dissemination level	Public	
Written By	Jorg Coolegem (NFCT)	27-06-18
Checked by	Paddy Hayes (JMFC)	28-6-18
Approved by	Ton Pichel (ANIC)	29-6-18
Issue date	29-06-2018

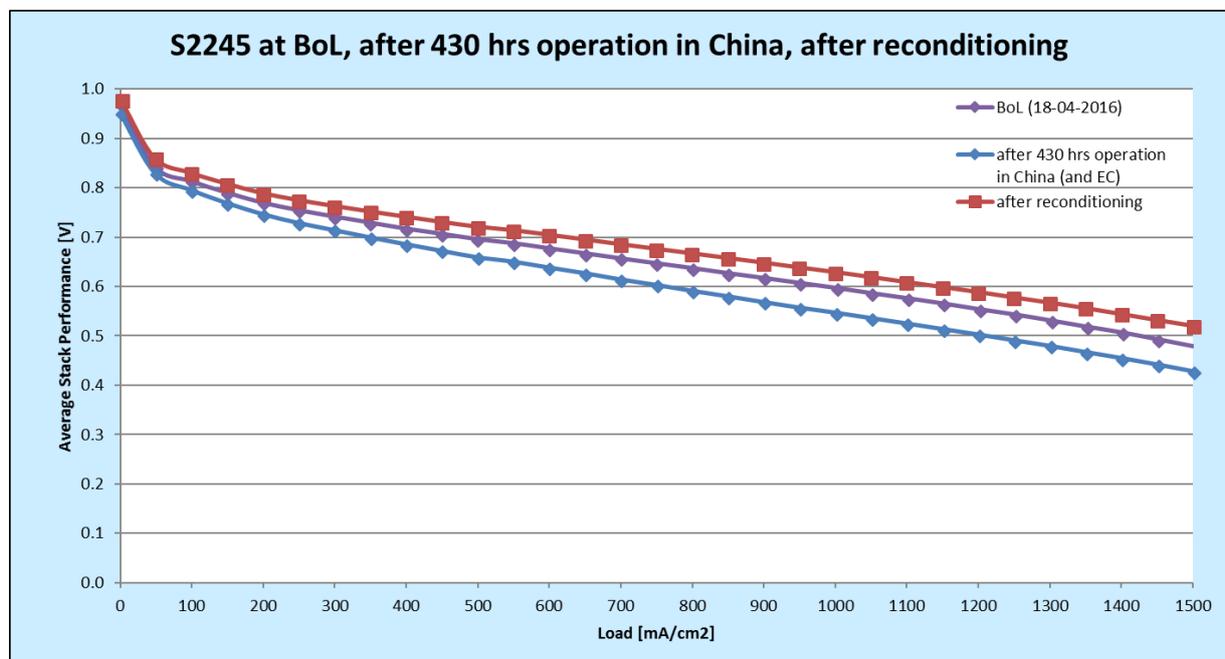
Fig. 1 – IV curves of a typical stack showing some voltage loss between BoL and return from China, and a (more than) full recovery after reconditioning.

A relatively high performance loss is measured upon return from China. In step 3, in total only 14 cells were replaced for the whole batch, so on average only 2 cells/stack, adding a negligible contribution to the performance raise as observed in the final performance curve. After Nedstack’s reconditioning protocol in step 3, the original BoL performance was virtually restored.

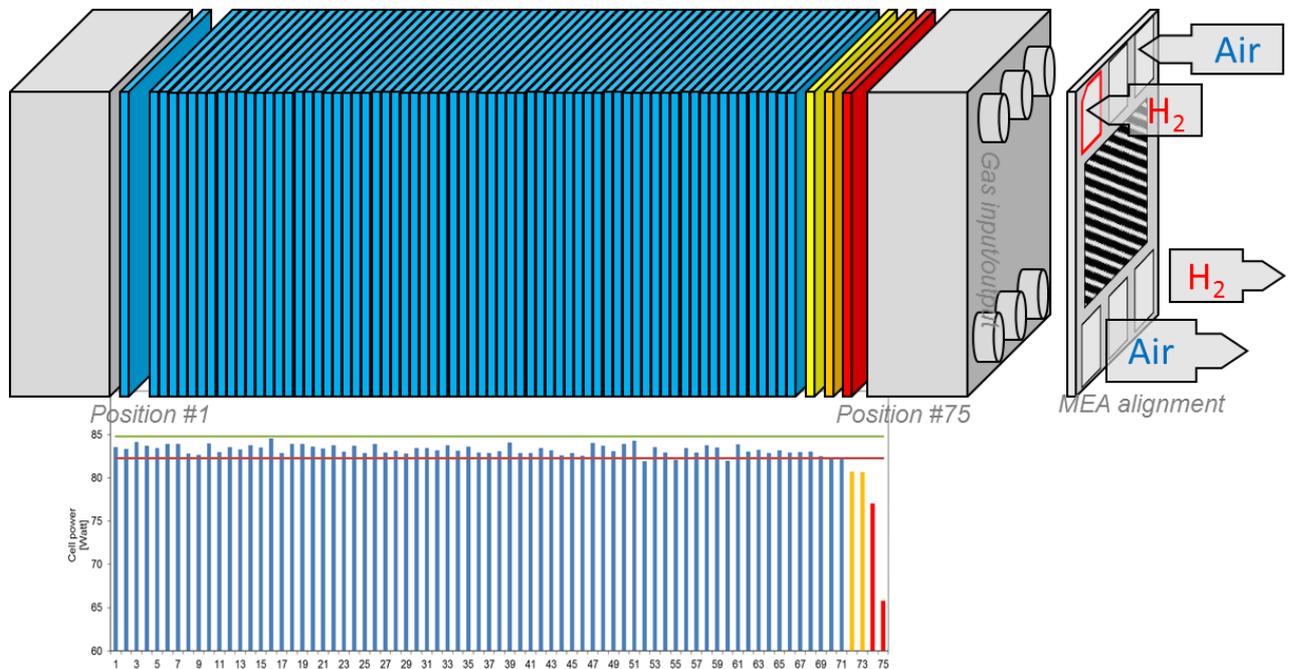
As also reported in the MS7.1 report most of the cell trips could be explained by clogged anode inlet areas in the entrance cells (75, 74). External particle contamination (i.e. from outside the stacks), is easily dragged downstream the anode-subsystem where it deposits in the first cells, i.e. cell 75 of stacks in G6 M4, see also Fig. 2.

Fig. 2 – schematic representation of stack, combined with observed cell performance as a result of particle contamination.

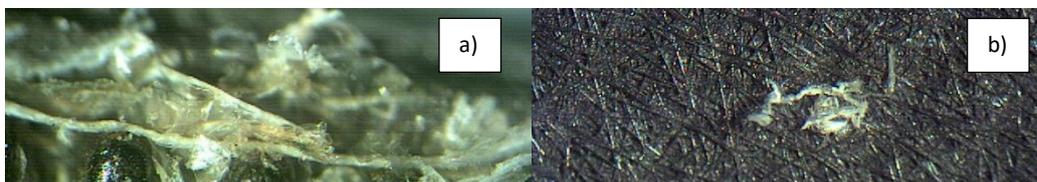
The removed cells were visually inspected, which clearly revealed the cause of the low cell voltage trips in all cells 75. The entrance of the flow field channels on the anode (i.e. hydrogen) side was blocked, mainly by whitish, polymeric fiber fragments as shown in Fig 3. by light microscopy

Fig. 3 a,b – light microscopy pictures of the particle contamination found, a) clogging the anode inlet side of cells 75 of repair stacks and b) detail of a similar fiber deposited on the GDL of the MEA

The Teflon fragments must have originated from the upstream system. Teflon tape is commonly used as thread seal tape (in hydrogen sub-) systems, also in the BoP of the 2 MW unit. Care should be taken to prevent the presence and release of loose fragments. Also improved filtration could be considered: the current hydrogen inlet filter is not optimal as it may allow leak through of particles, while also additional (temporary) filters could be considered, for example in the hydrogen recirculation loop.

A number of stacks at particular positions have shown to be susceptible to anode inlet clogging of fine particles, Teflon fibers in this specific case. For that reason, installation of an improved particle filter in the hydrogen feed line could be considered as well as installation of additional downstream filters.

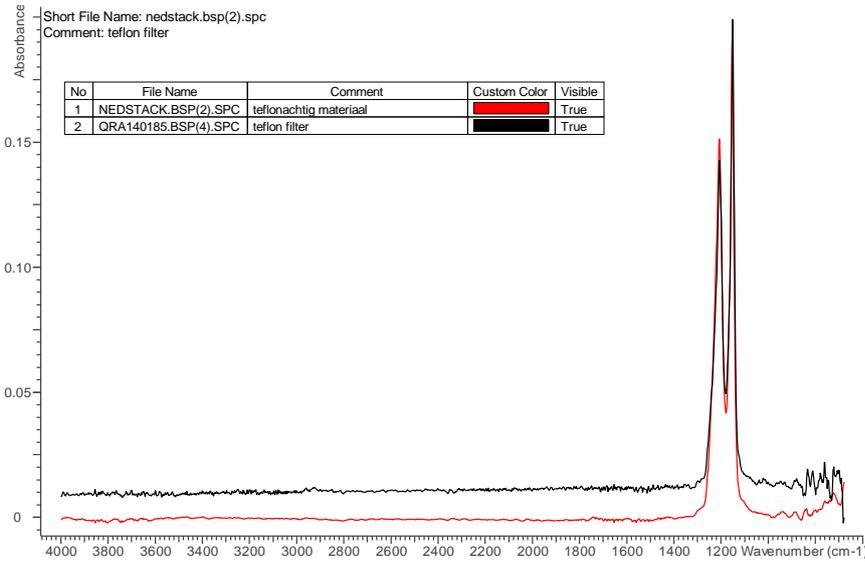
A typical particle was isolated and analyzed by IR and found to be Teflon as shown in Fig. 4.

Fig. 4 - IR spectrum of particles clogging the anode of cell 75 vs. a Teflon reference

The obstructing particles from several cells 75 were collected and also analyzed via SEM-EDS. In addition to the Teflon particles, also some iron/stainless steel particles were found. Both materials are not used in the fuel cell stacks and must have an external origin (e.g. the hydrogen feed line or the anode sub-system of the BoP).
